NBSIR 82-2465 (A)

# Investigation of the Kansas City Hyatt Regency Walkways Collapse

February 1982

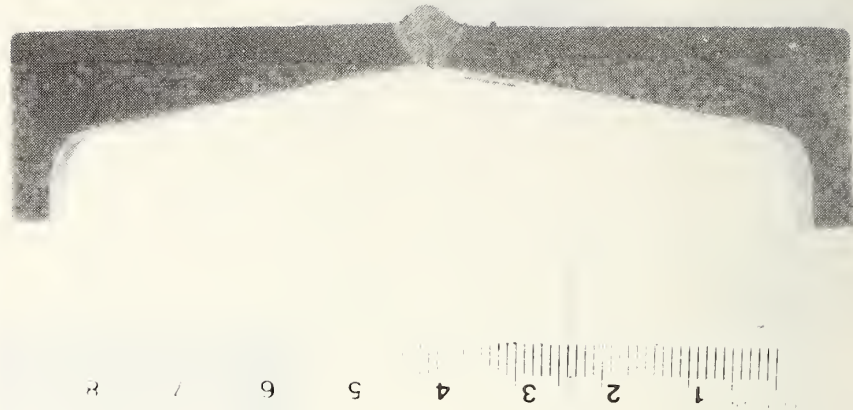
Figure A7.4.1-1 Transverse section through NBS weldment IC welded by the GMAW process using mild steel welding rod. The weld is in the center connecting flange parts of the two channel segments, Parts of the web regions of each channel are also included in the section. Etchant: two percent nital ~X1

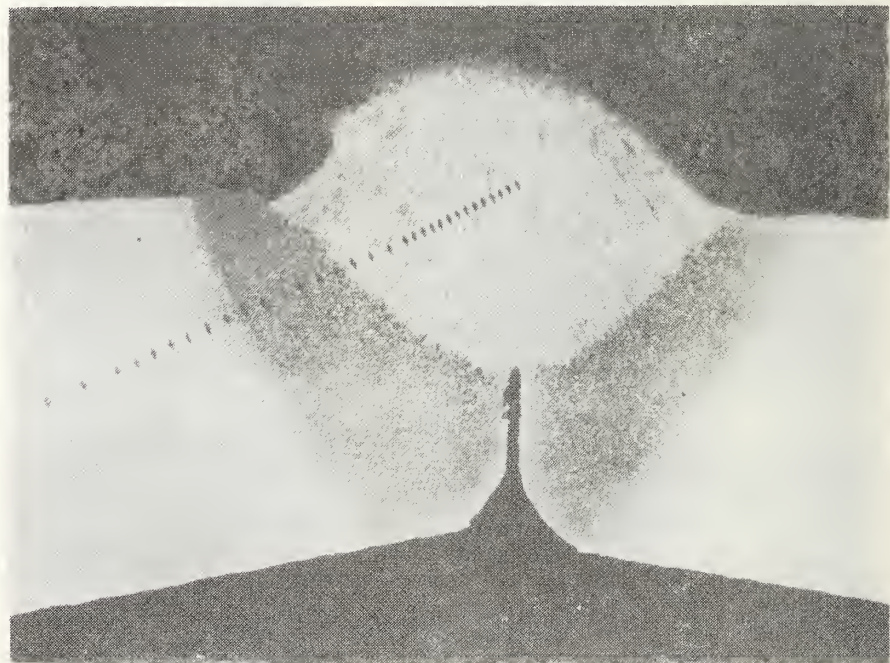
Figure A7.4.1-2. Part of the transverse section shown above, but a higher magnification. The light region in the center is weld metal. The dark regions adjacent to the weld metal are the heat affected zones. The light regions to the left and right in the photograph represent base flange regions of the channel segments. The line of small dark, elongated marks is the result of microhardness measurements. Etchant: two percent nital. X8.5

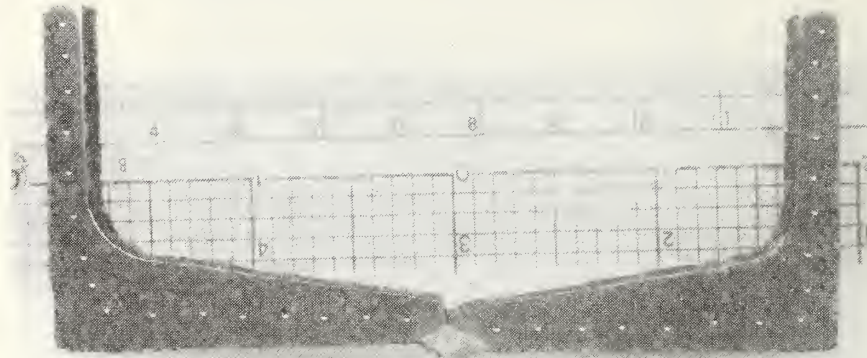
Figure A7.4.1-8 Transverse section 1B1 through the bottom of walkway box beam 9U (NBS 1). The north channel of the box beam is to the left and the south channel is to the right. The weld connecting the flanges of the two channels used to fabricate the box beam is in the center. Parts of the web regions of each channel had been removed before this photograph was taken. The indentations appearing on the surface of the section are the result of hardness measurements.  
Etchant: two percent nital. ~X1

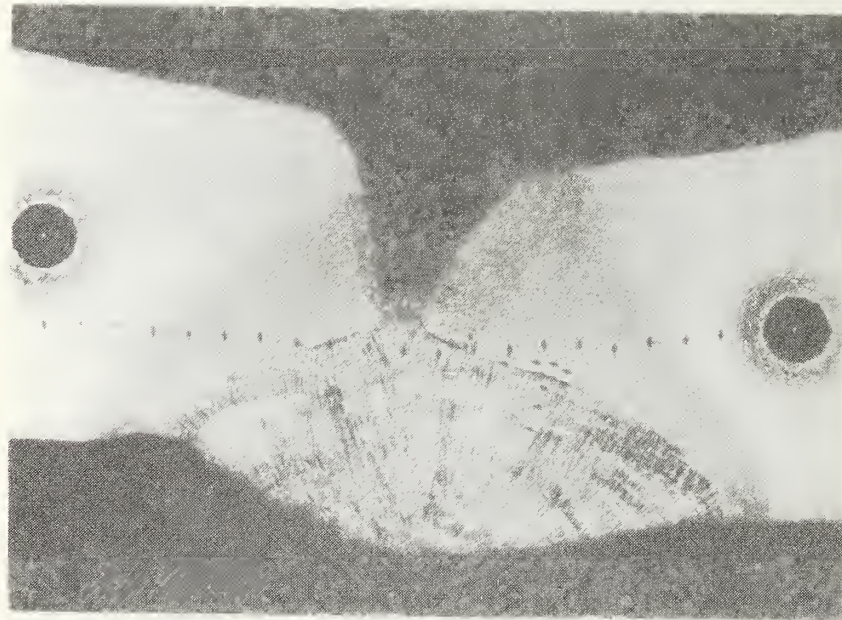
Figure A7.4.1-9 Part of the transverse section shown in figure A7.4.1-8, but at higher magnification. The region at the bottom center is weld metal. The dark gray regions on either side of the weld metal are the heat affected zones associated with the weld. The lighter regions at either side of the figure beyond the heat affected zone are base channel material.  
Etchant: two percent nital. X8.5

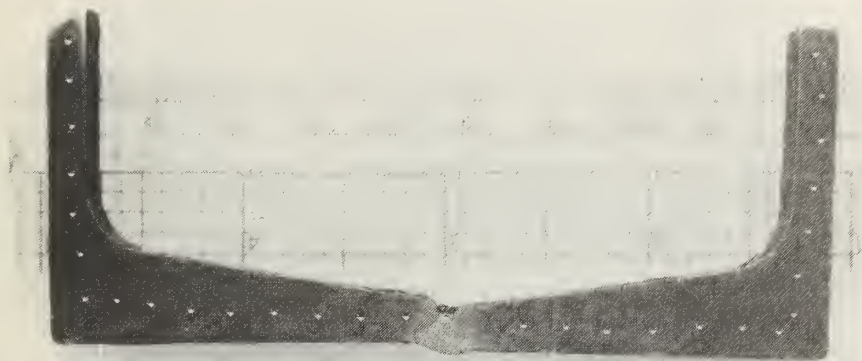
Figure A7.4.1-10 Transverse section 1BM2 through the bottom of walkway box beam 9U (NBS 1). The north channel of the box beam is to the left and the south channel is to the right. The weld connecting the flanges of the two channels used to fabricate the box beam is in the center. Parts of the web regions of each channel had been removed before this photograph was taken. The indentations appearing on the surface of the section are the result of hardness measurements. Etchant: two percent nital. ~X1

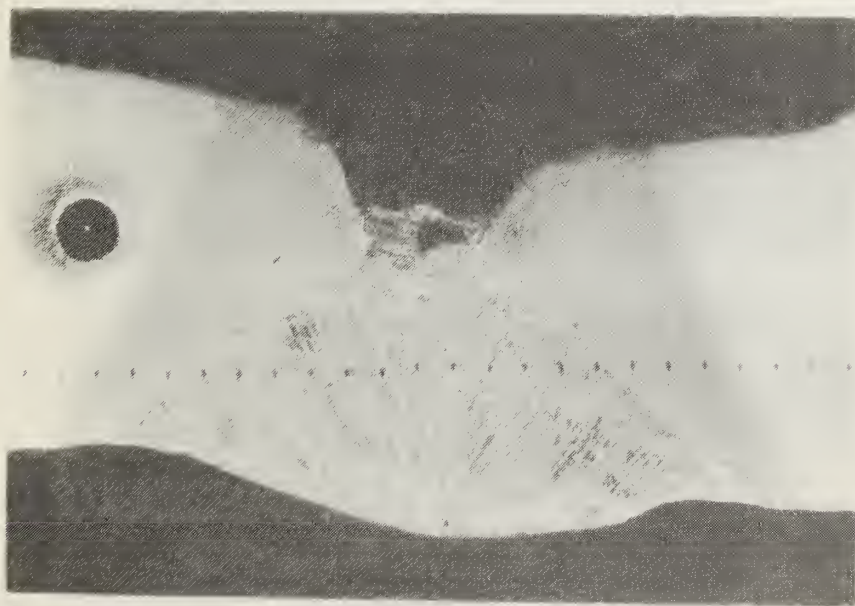
Figure A7.4.1-11 Part of the transverse section shown in figure A7.4.1-10, but at higher magnification. The region at the bottom center is weld metal. The dark gray regions on either side of the weld metal are the heat affected zones associated with the weld. The lighter regions on either side of the photomicrograph are base channel material. Etchant: two percent nital. X8.5

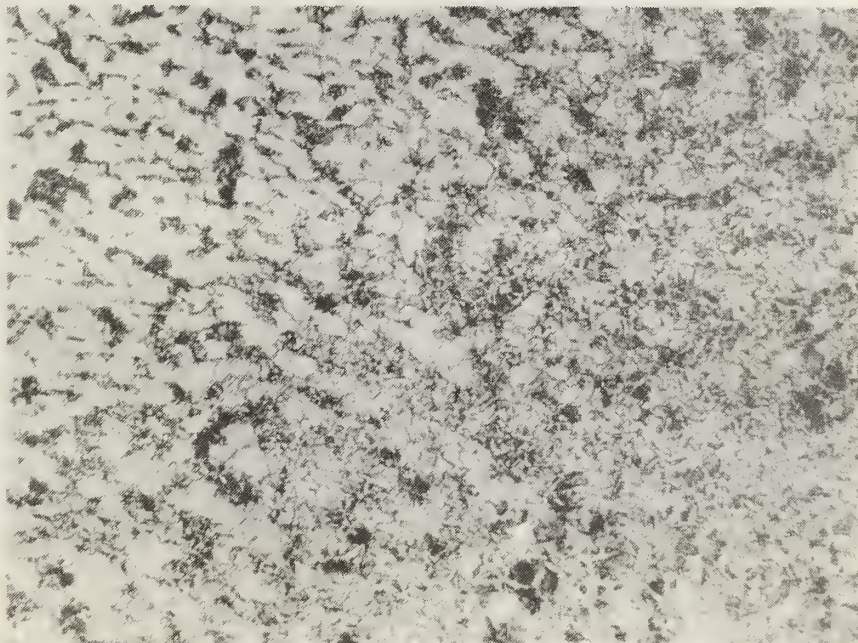
Figure A7.4.1-19 Transition from heat affected zone (right) to base channel material (left) in section 1BM2. Etchant: two percent nital. X200

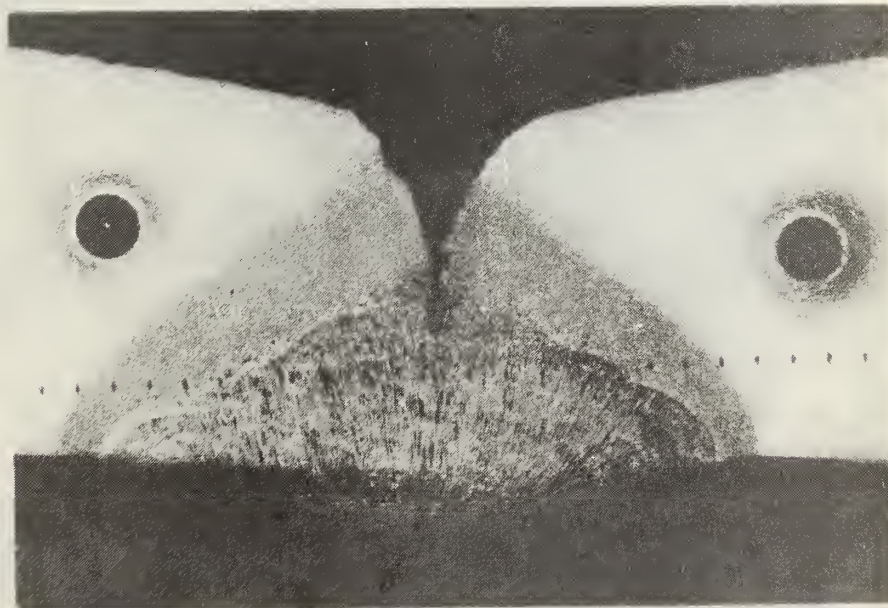
Figure A7.4.1-22 Part of the transverse section shown in figure A7.4.1-21, but at higher magnification. The region at the bottom center is weld metal. The dark gray regions on either side of the weld metal are the heat affected zones associated with the weld. The lighter regions on either side of the figure beyond the heat affected zones are base channel material. Etchant: two percent nital. X8.5

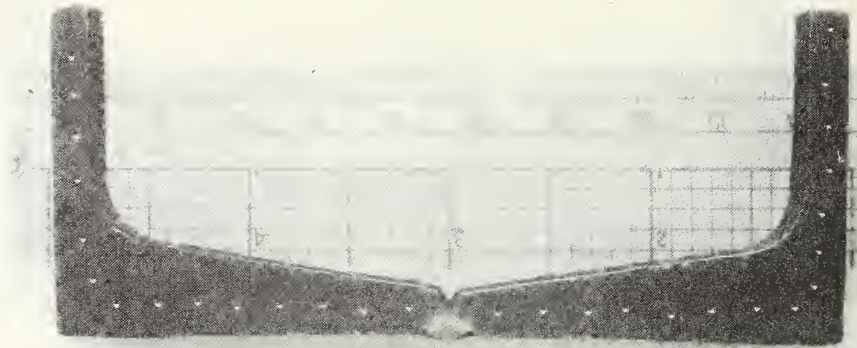
Figure A7.4.1-23 Transverse section 2BM2 through bottom of walkway box beam 8L (NBS 2). The north channel of the box beam is to the left and the south channel is to the right. The weld connecting the flanges of the two channels used to fabricate the box beam is in the center. Parts of the web regions of each channel had been removed before this photograph was taken. The indentations appearing on the surface of the section are the result of hardness measurements. Etchant: two percent nital. X1

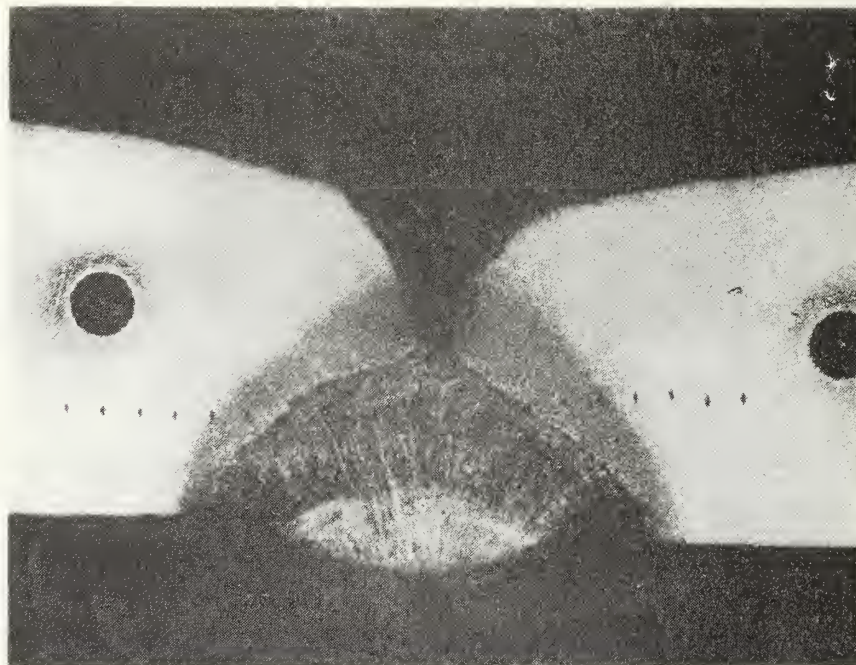
Figure A7.4.1-24 Part of the transverse section shown in figure A7.4.1-23, but at higher magnification. The region at the bottom center is weld metal. The gray regions on either side of the weld metal are the heat affected zones associated with the weld. The lighter regions on either side of the figure beyond the heat affected zones are base channel material. Etchant: two percent nital. X8.5

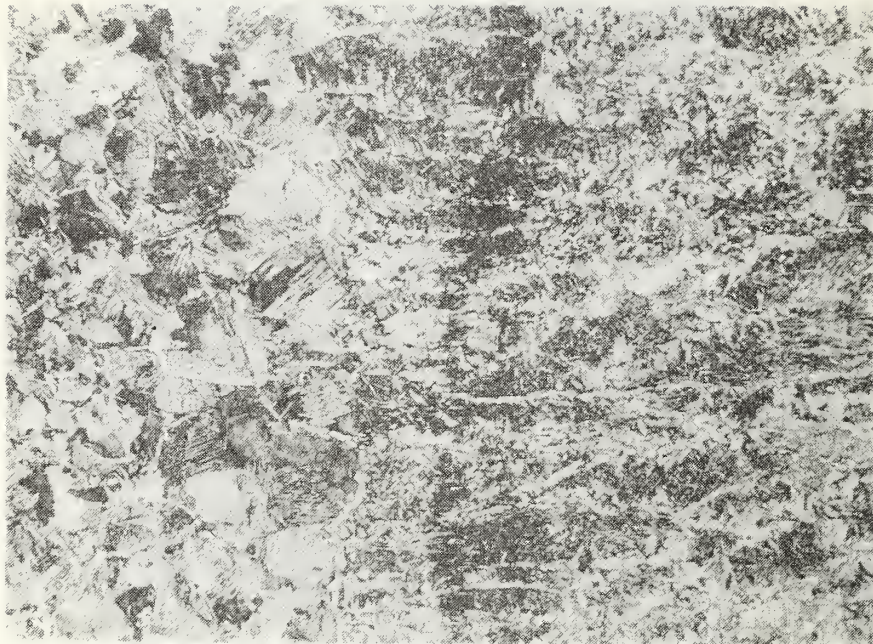
Figure A7.4.1-27 Transition zone from weld metal (right) to heat affected zone (left) in section 2BM1. Etchant: two percent nital. X200

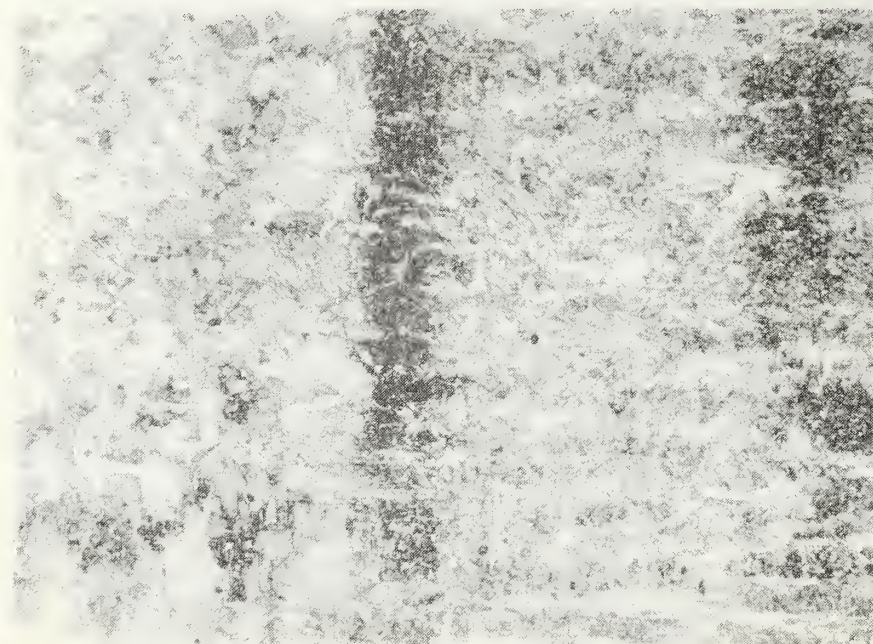
Figure A7.4.1-28 Transition zone from weld metal (right) to heat affected zone (left) in section 2BM2. Etchant: two percent nital. X200

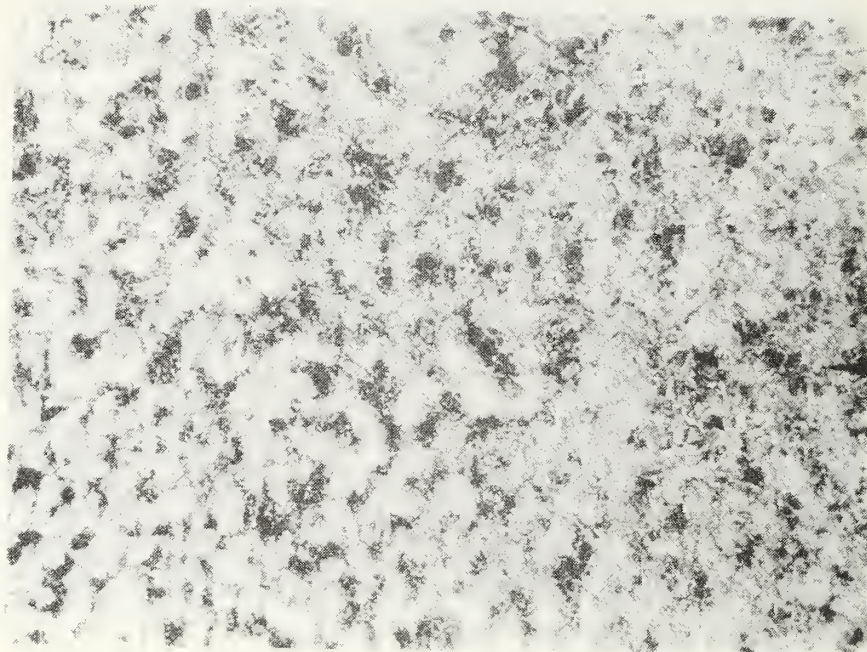
Figure A7.4.1-31 Transition region from heat affected zone (right) to base channel material (left) in section 2BM1.  
Etchant: two percent nital. X200

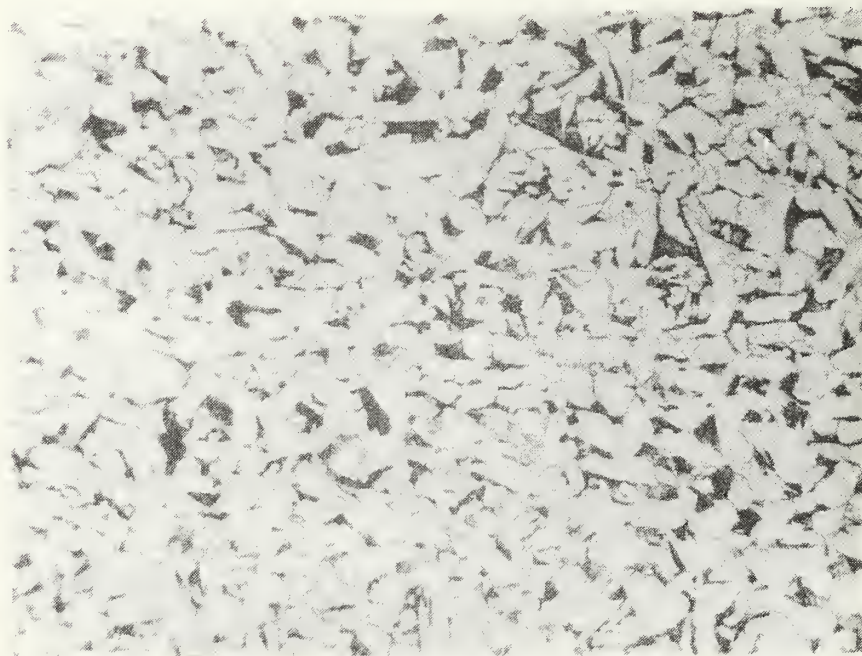
Figure A7.4.1-32 Region of section 2BM1 representative of the base channel material in both sections through box beam 8L. The microstructure consists primarily of ferrite (light) and pearlite (dark) in the normalized condition. Etchant: two percent nital. X200

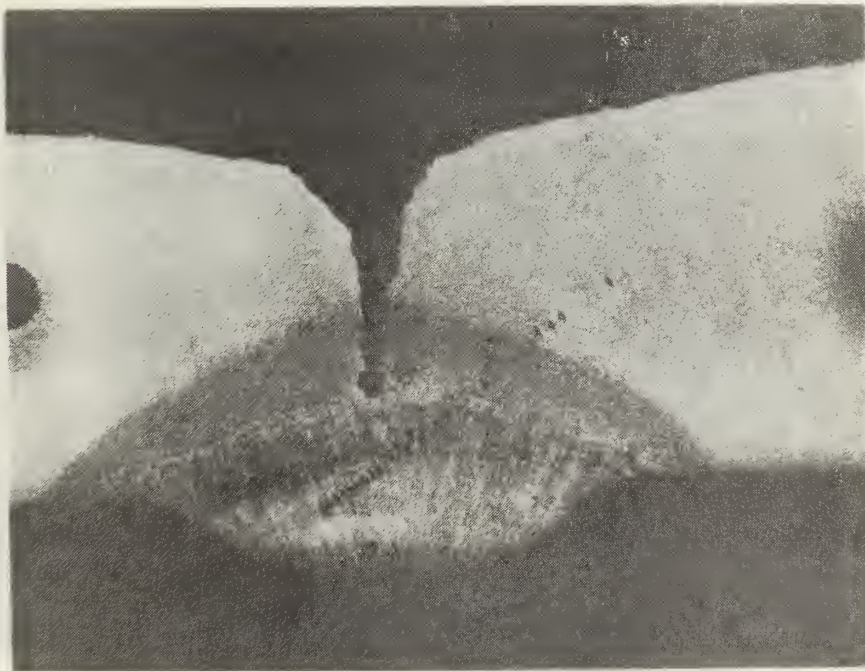
Figure A7.4.1-34 Part of the transverse section shown in figure A7.4.1-33, but at higher magnification. The region at the bottom center is weld metal. The gray regions on either side of the weld metal are the heat affected zones associated with the weld. The lighter regions at either side of the figure beyond the heat affected zone are base channel material.  
Etchant: two percent nital. X8.5

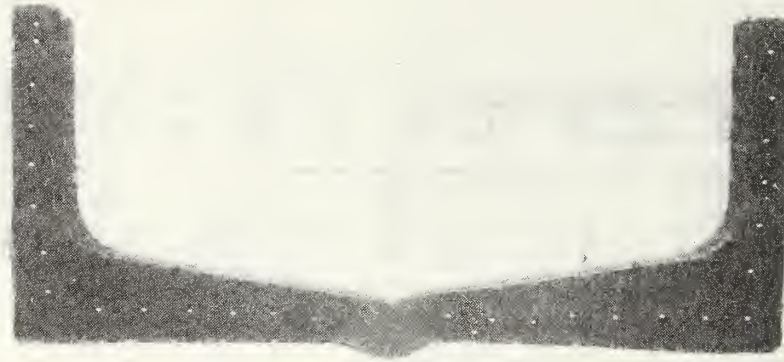
Figure A7.4.1-35 Transverse section 3BM2 through the bottom of walkway box beam 9M (NBS 3). The south channel of the box beam is to the left and the north channel is to the right. The weld connecting the flanges of the two channels used to fabricate the box beam is in the center. Parts of the web regions of each channel had been removed before this photograph was taken. The indentations appearing on the surface of the section are the result of hardness measurements. Etchant: two percent nital. ~X1

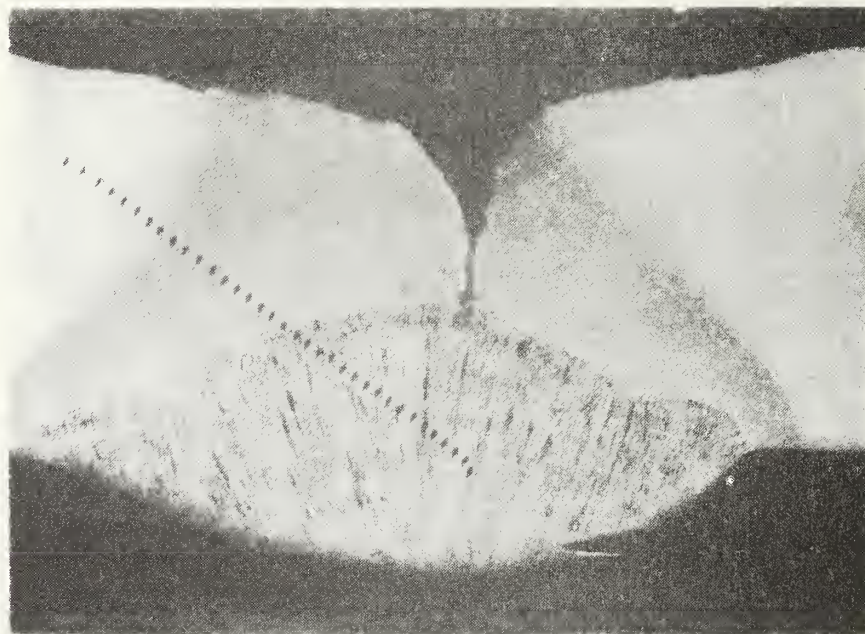
Figure A7.4.1-36 Part of the transverse section shown in figure A7.4.1-35, but at higher magnification. The region at the bottom center is weld metal. The gray regions on either side of the weld metal are the heat affected zones associated with the weld. The lighter regions at either side of the figure beyond the heat affected zones are base channel material. Etchant: two percent nital. X8.5

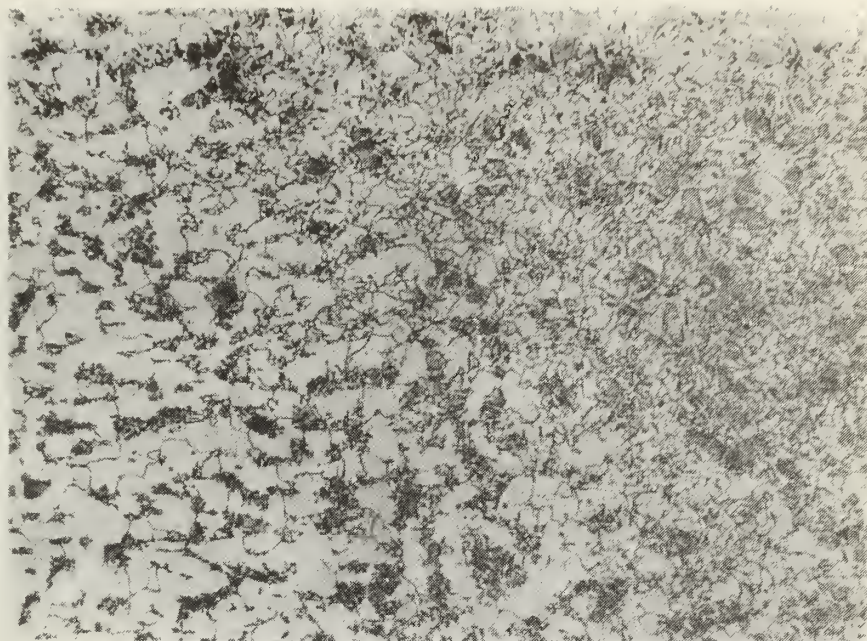
Figure A7.4.1-41 Transition zone from heat affected zone (right) to base channel material (left) in section 3BM2.  
Etchant: two percent nital. X200
